**NASA Contractor Report 180809**

**EVALUATION OF COATED COLUMBIUM TEST  
PANELS HAVING APPLICATION TO A  
SECONDARY NOZZLE EXTENSION FOR THE  
RL10 ROCKET ENGINE SYSTEM; PARTS I  
AND II**

**FINAL REPORT**

*Pratt & Whitney  
Government Engine Business  
P.O. Box 109600  
West Palm Beach, Florida 33410-9600*

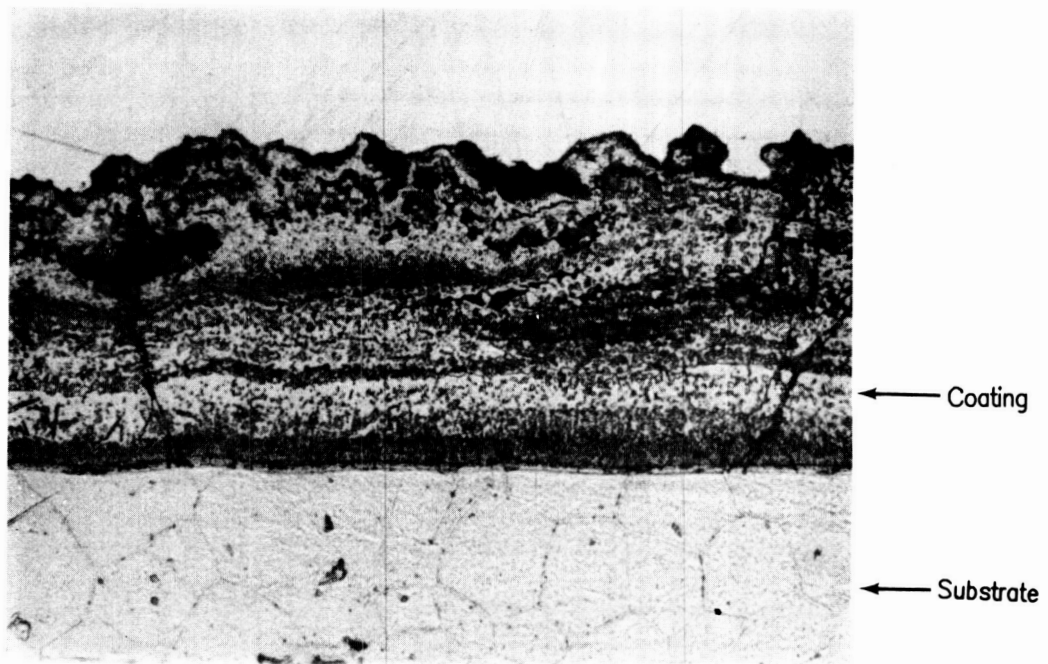
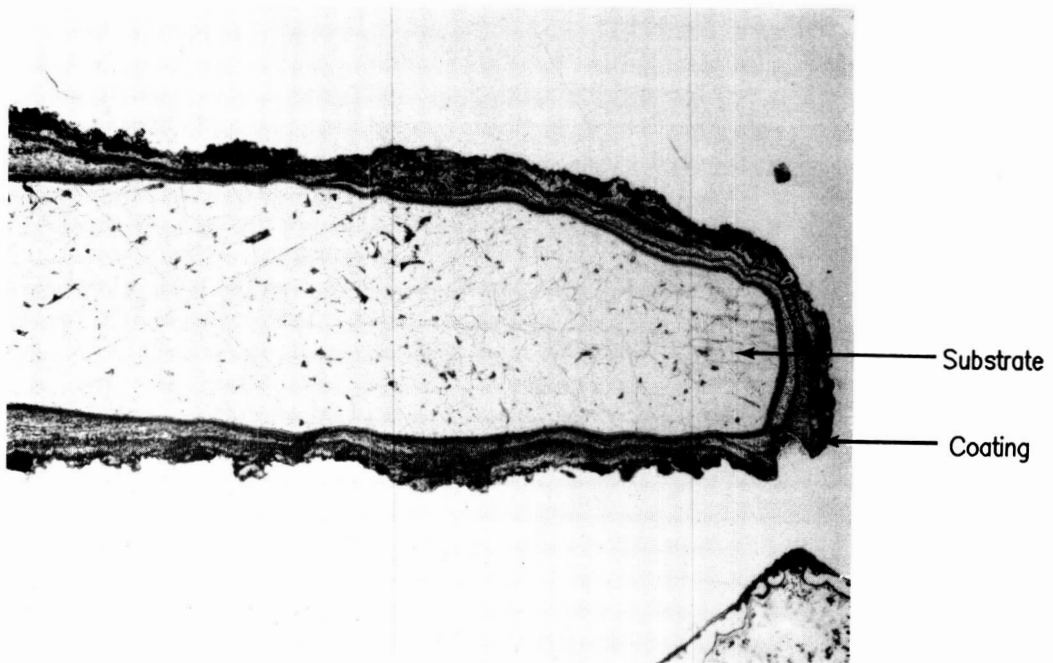
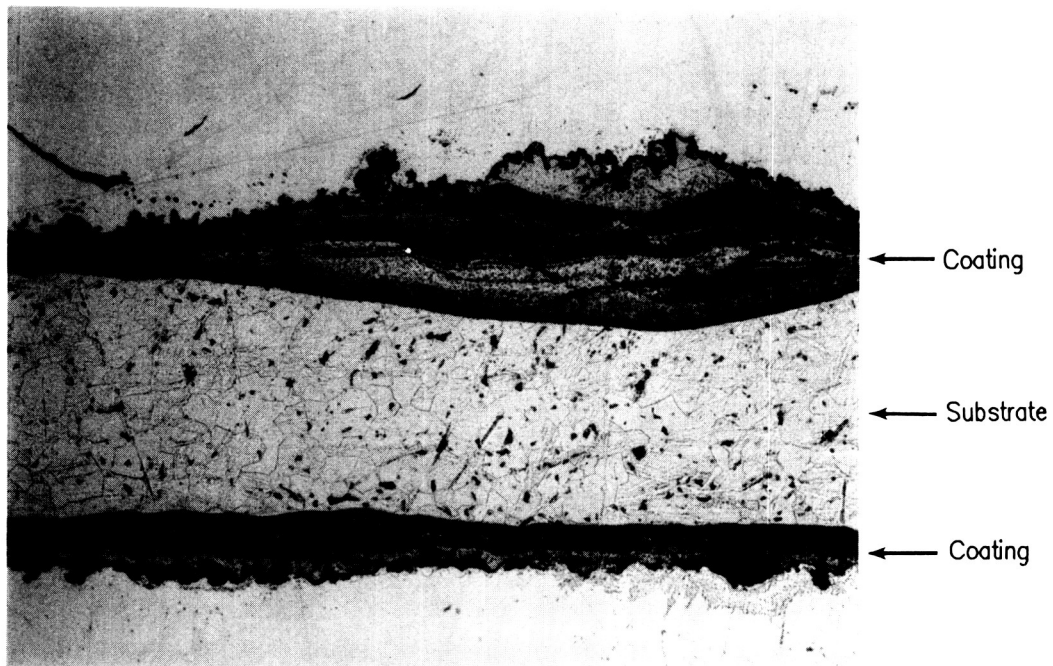
Figure 2-21. Vac Hyd VH-9 Microstructure (Etch: 60% Lactic; 20%  $\text{HNO}_3$ ; 20%  $\text{Hf}$ ;  
Thickness:  $2.6 \pm 1.5$  mils) (Sheet 1 of 2)

The as-received VH-9 panel was dark gray with many surface protuberances near the panel edges (Figures 2-18 and 2-19). The panel was visually thinner than uncoated panels, and metallography confirmed this observation (Figures 2-20 and 2-21). The coating thickness was inconsistent, ranging between 7.0 mils at protuberances to 1.5 mils in other locations. The substrate thickness was thin, ranging from 7.0 to 9.5 mils. No logical explanation for the large deviation from the original 15-mil panel thickness can be determined. The microstructures in Figure 2-21 readily depict the inconsistent nature of this coating/substrate system. Microprobe analysis showed the coating was layered (Figure 2-22). The outer region was rich in Si with some Cr. The apparent interdiffusion zone was rich in Al. Locally high concentrations of Si, Cr, Ti, Hf and Al were present throughout the coating. The detection of Si and Cr was unexpected in the microstructure. No plausible explanation was offered by the vendor.

The VH-9 coating is not recommended for additional testing: (1) the coating thickness varies to greatly for a quality coating, (2) substantial substrate thickness was consumed by the coating process, (3) target and measured coating chemistries did not agree. However, the resultant layered nature of this coating is unique and may be a good approach to protect columbium alloys.

Non-Uniform Coating Thickness  
and Interaction With C-103 Substrate

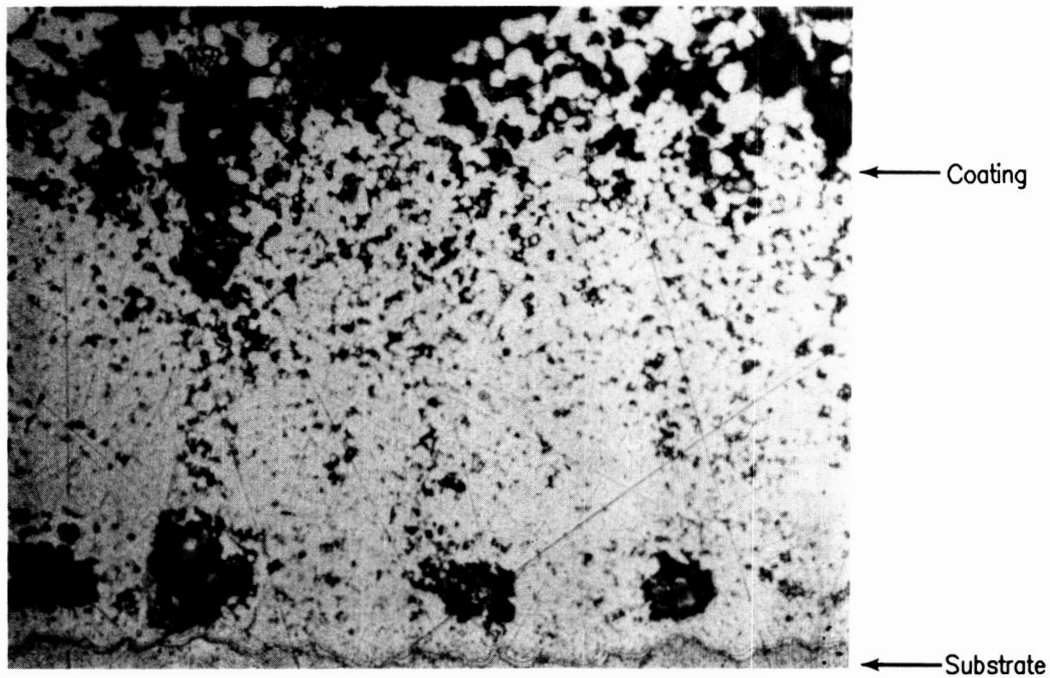
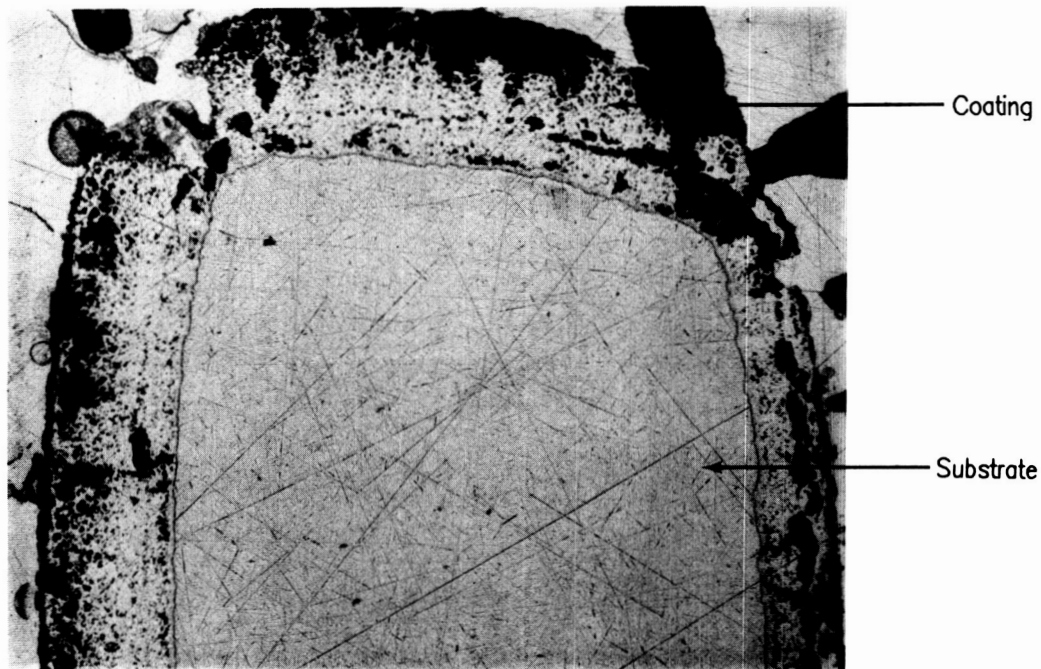
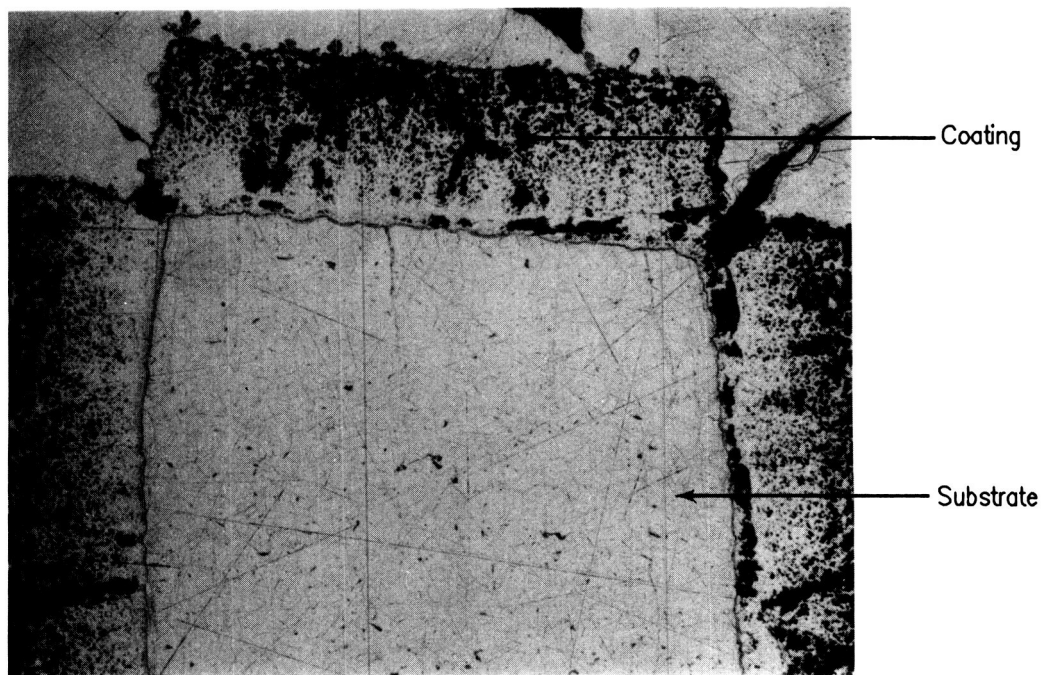
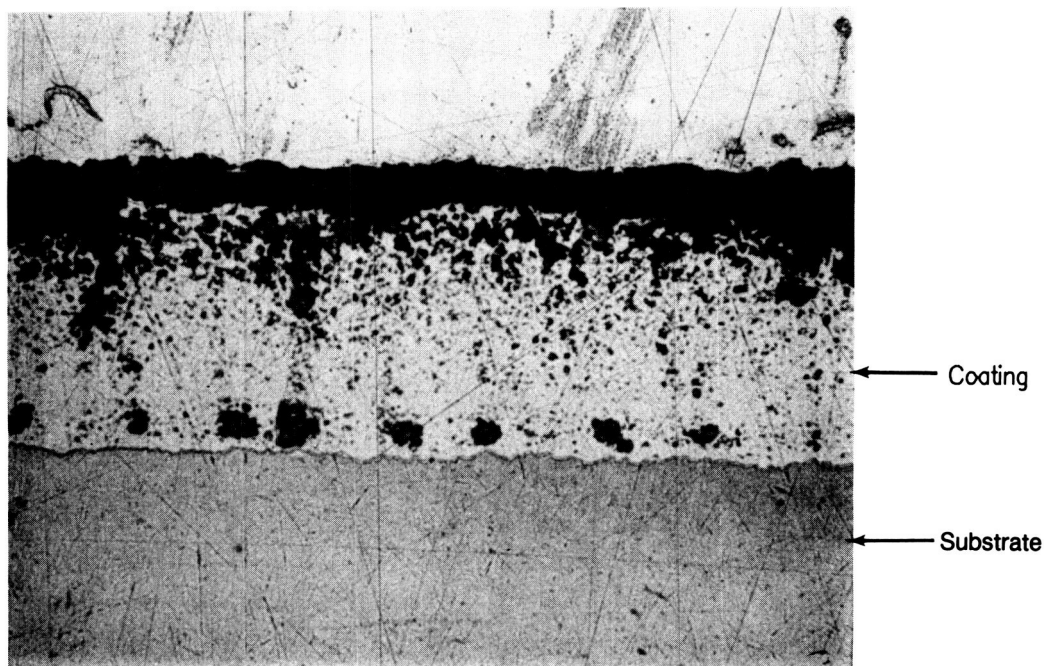
Figure 2-31. Vac Hyd VH-2 Microstructure (Etch: 60% Lactic; 20%  $\text{HNO}_3$ ; 20%  $\text{Hf}$ ;  
Thickness:  $5.3 \pm 0.8$  mils) (Sheet 1 of 2)

unusually thick, between 22.0 and 23.0 mils. Metallographically, the coating appears to be composed of spherical particles with very little interaction with the substrate (Figure 2-31). The particles were closely packed near the substrate and loosely held together near the external surface. Small voids in the coating about 0.6 mil above the coating/substrate interface evolved during metallographic polishing. Edge corners had unusual coating coverage. The coating did not cover corners uniformly and continuously. The microprobe detected only Al in the coating and discussions with Vac-Hyd confirmed the VH-2 composition as consisting essentially of Al (Figure 2-32).

The VH-2 coating was thicker than desired and had very limited interaction with the substrate. Substantial metallographic pull-out questions the structural integrity of the coating. Sample edges were not thoroughly coated; again, this could lead to premature base alloy degradation.

Side 1: Panel Corner Coating Showing Non Uniformity

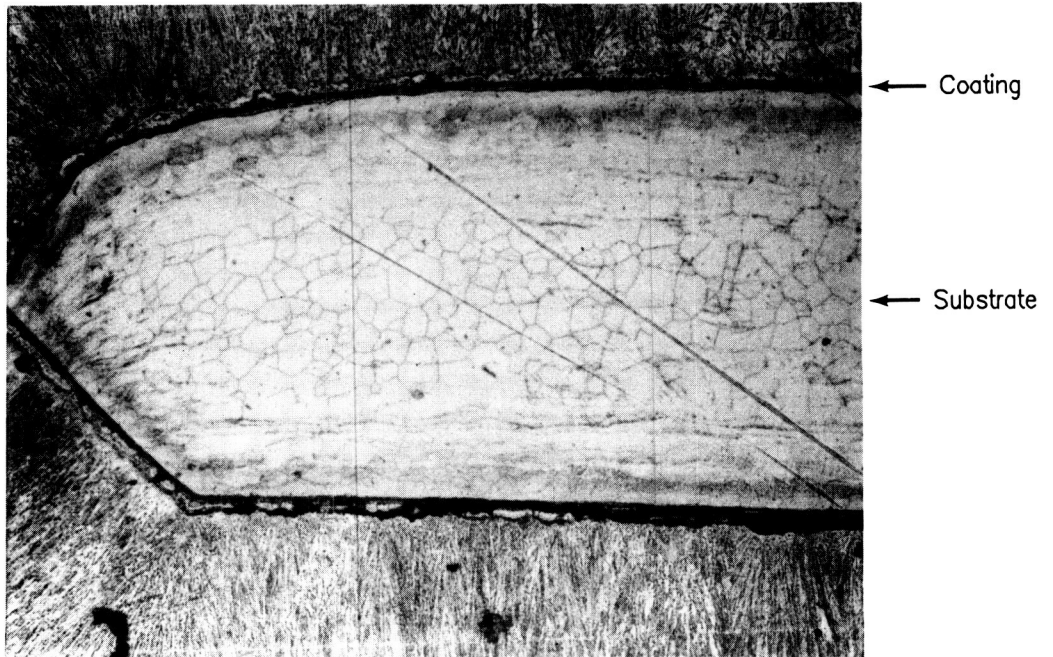
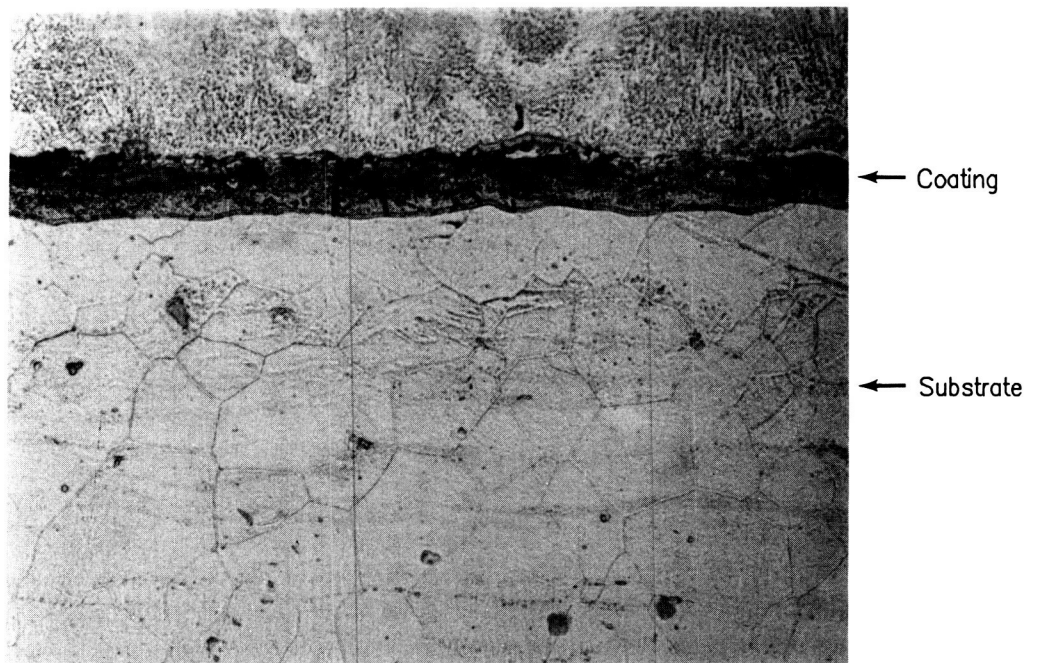
**Figure 2-36.** *Chromalloy RT-40 Microstructure (Etch: 60% Lactic; 20%  $\text{HNO}_3$ ; 20%  $\text{Hf}$ ; Thickness:  $0.5 \pm 0.1$  mil)*

The RT-40 coating had numerous surface discolorations on both panel faces (Figures 2-33 and 2-34). Metallurgical evaluation of the coating was conducted on a test coupon. The coating thickness was significantly under the  $3.0 \pm 1.0$ -mil requirement (Figure 2-35). The coating thickness averaged  $0.5 \pm 0.1$  mil. The substrate thickness was about 17 mils. Metallographic results showed that the coating was uniformly thin with numerous through-thickness cracks (Figure 2-36). Microprobe results detected no Al in the coating (Figure 2-37). Si, Cr and Fe were detected in addition to the substrate elements. The vendor has been contacted regarding the composition of the coating. No satisfactory response was offered to explain the lack of Al and the presence of Fe in the coating.

The RT-40 coating is a combination of Chemical Vapor Deposited Si and Pack Deposited Al. However, no Al was detected and Cr and Fe were found in addition to Si. The vendor was unable to explain these chemistry discrepancies, thus, reproduction of this coating is unlikely. No further work on RT-40 is recommended.

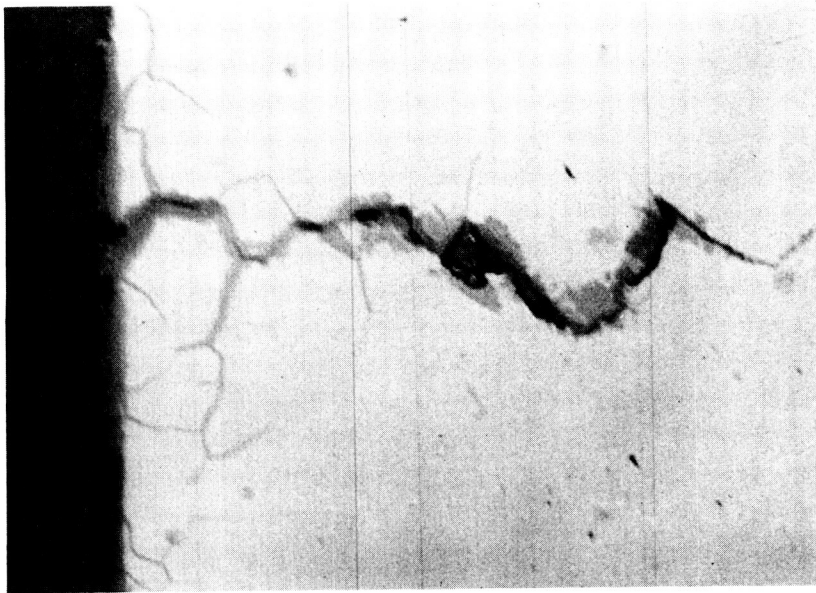
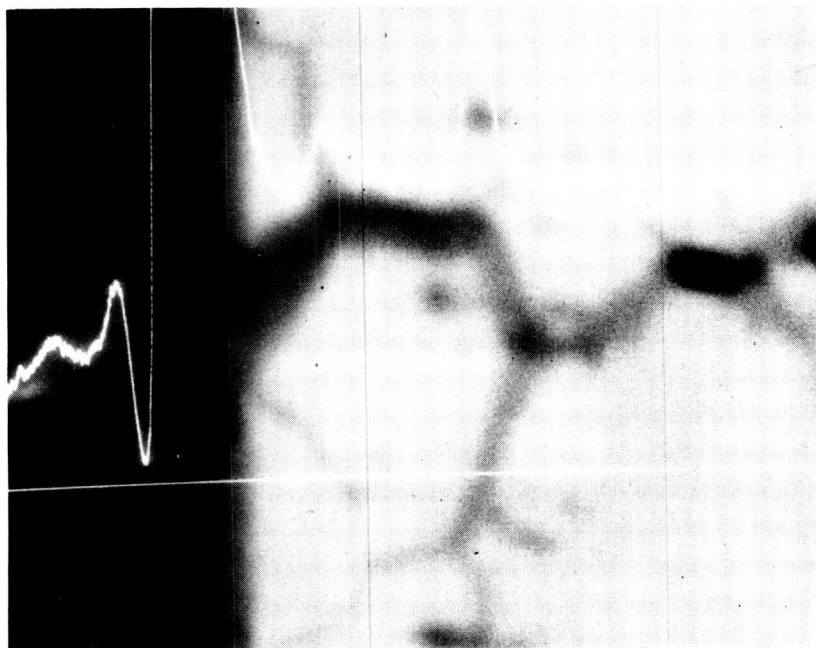
(a)  
General Location Showing Oxide  
Scale and Intergranular Cracking

(b)  
Line Scan Showing Oxygen Peaks at  
Sample Surface and Grain Boundaries

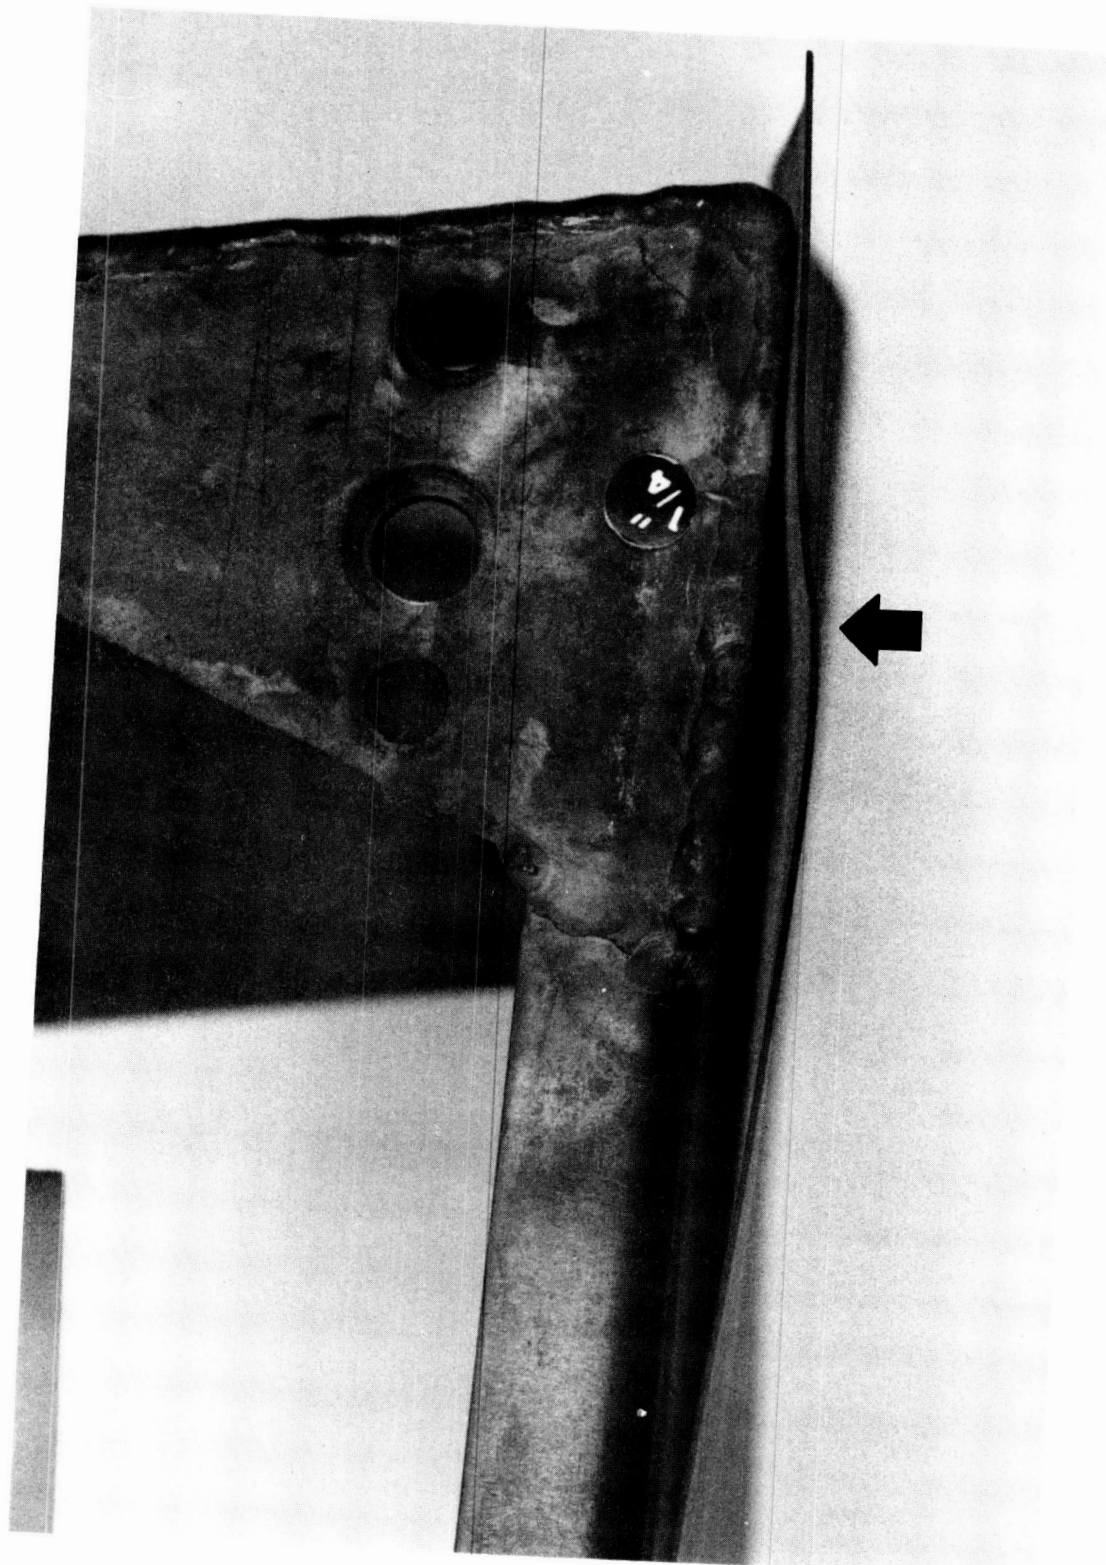
*Figure 3-12. Warping of VH-109 Panel (Arrow Indicates Crack Location)*

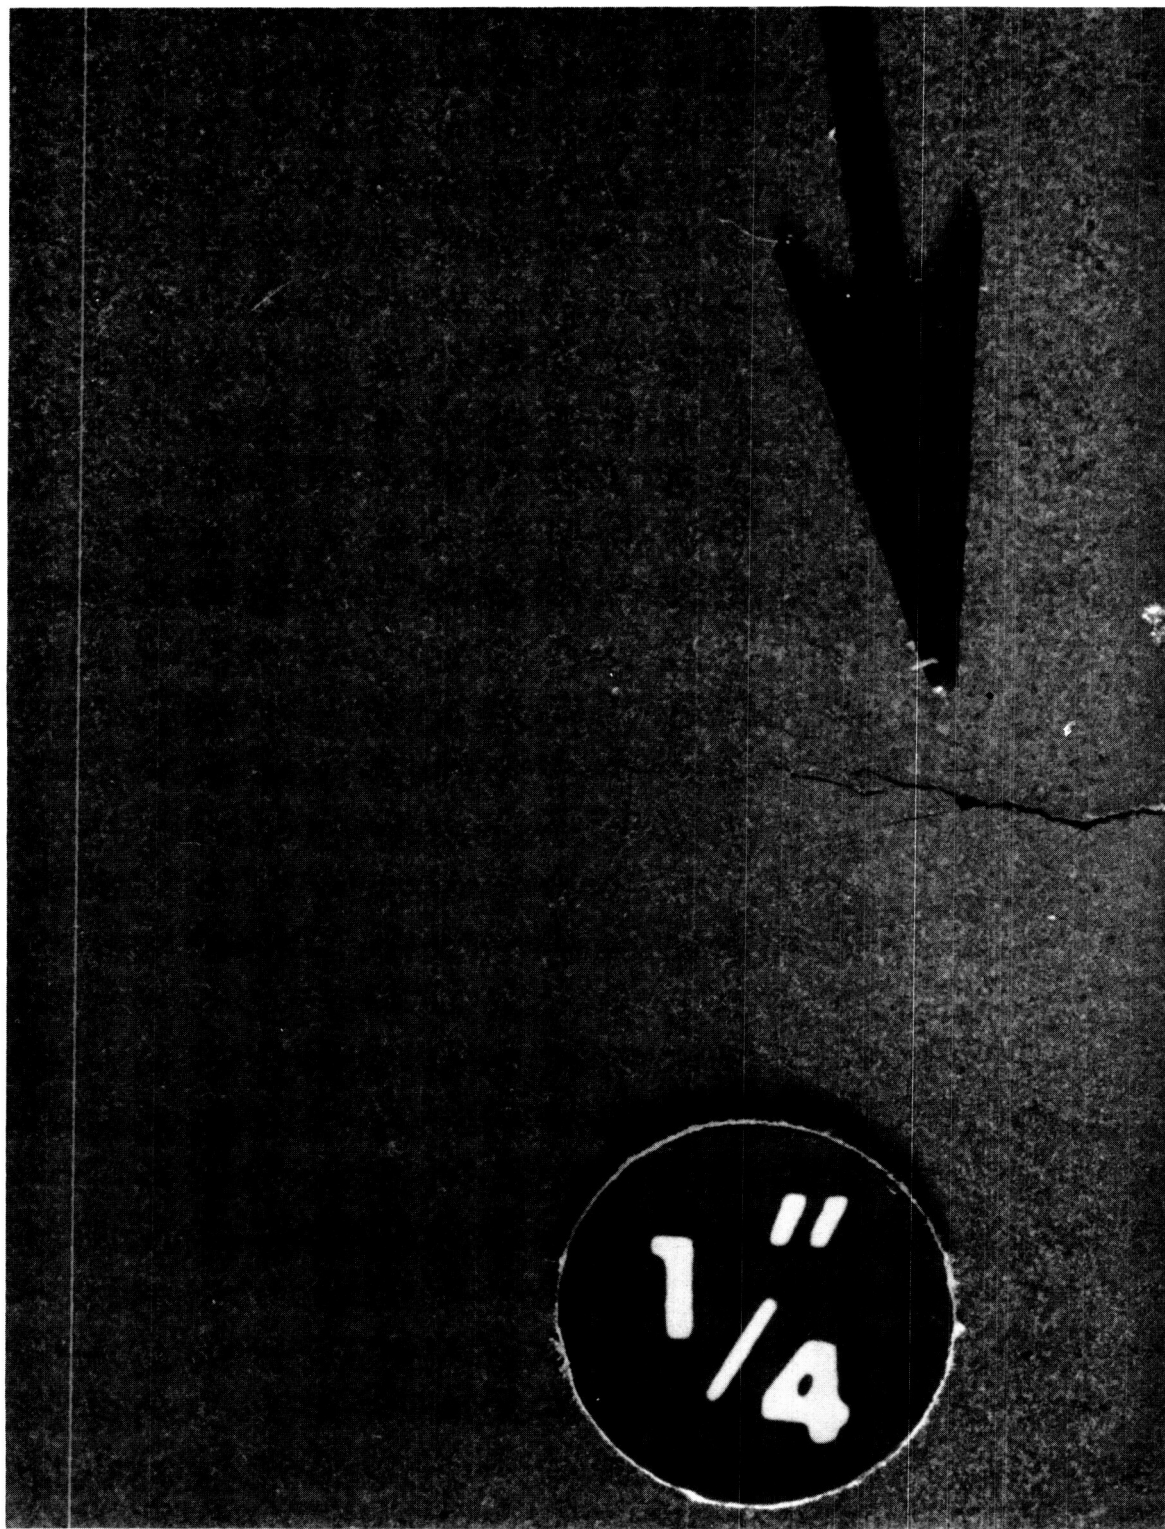
*Figure 3-13. Gas-Path View of Crack in VH-109 Panel*

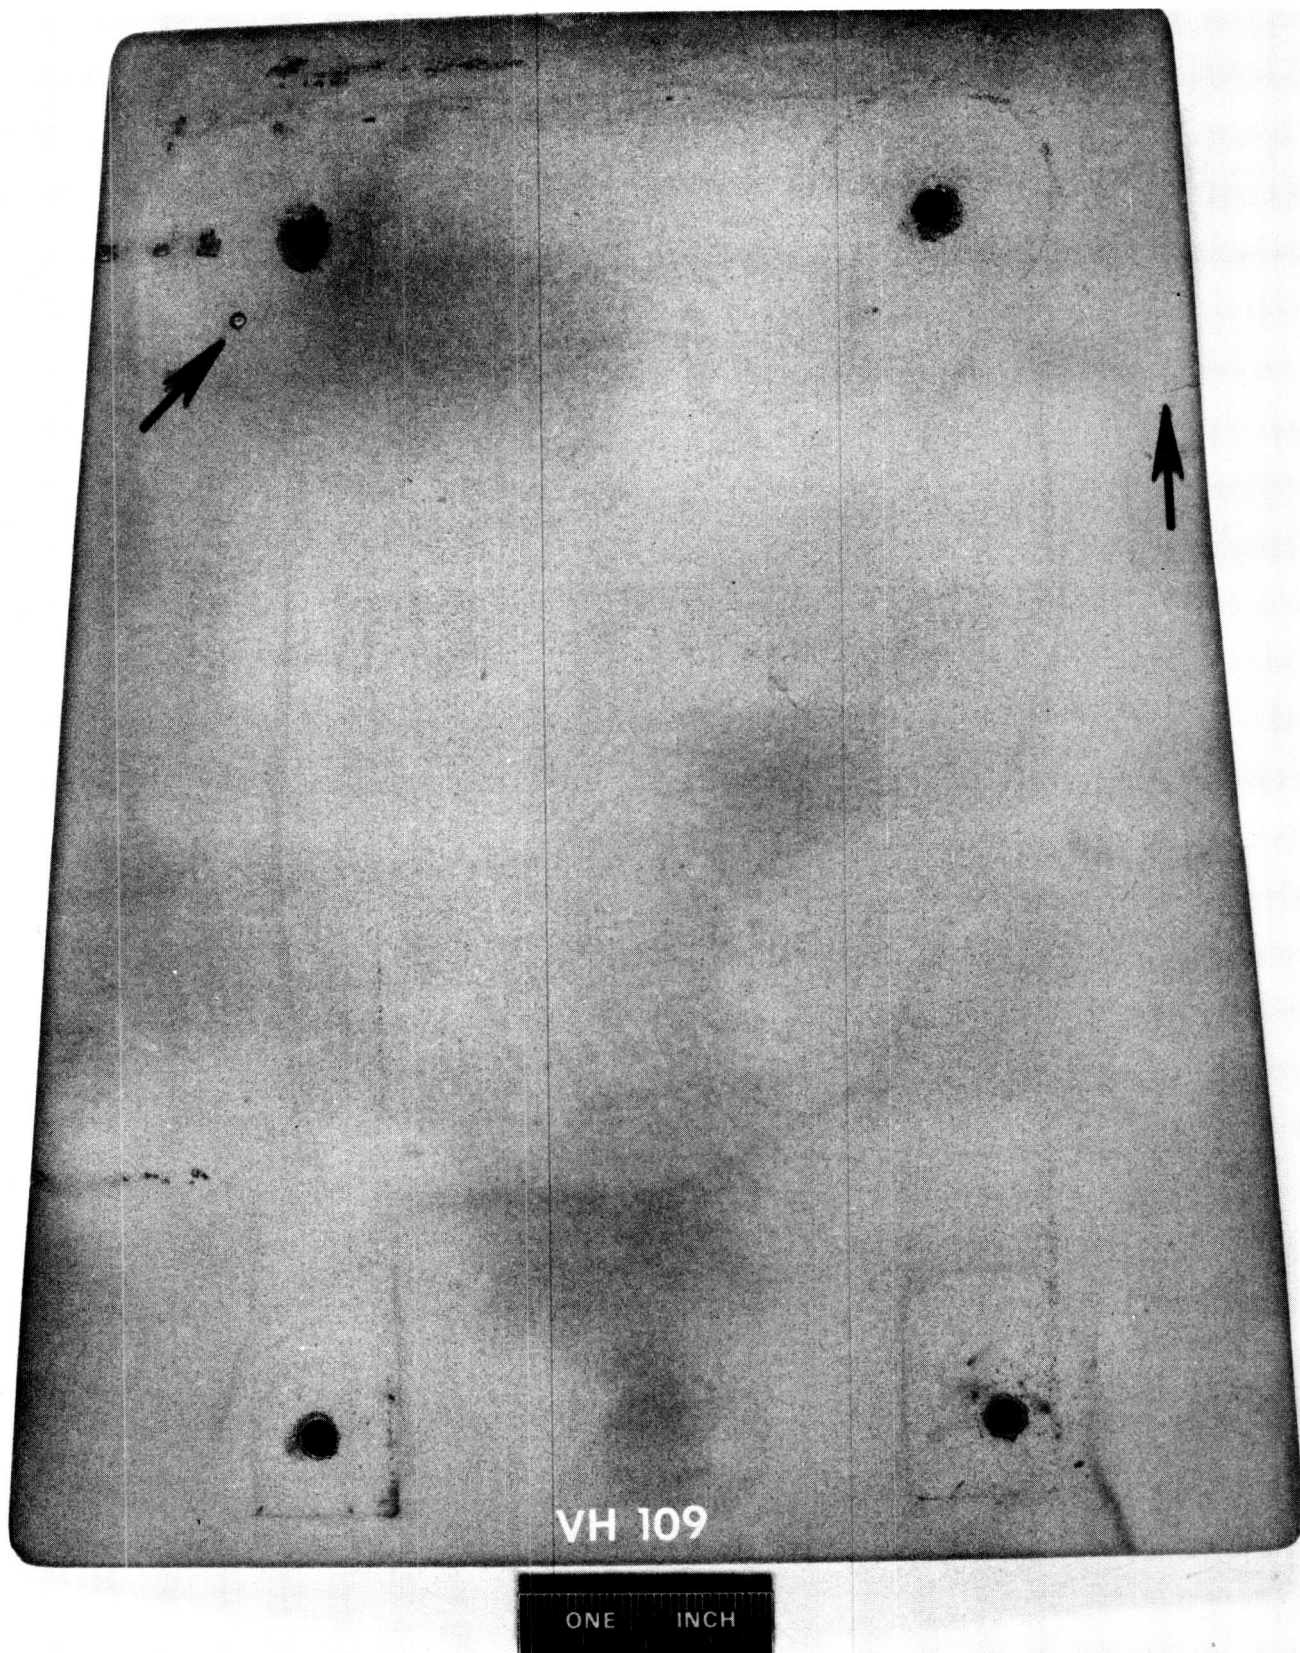
*Figure 3-14. Chamber Environment Side of VH-109 Coated C-103 Test Panel (Note: Arrow Points to Pinhole Oxidation Which Correlates to Surface Blemish on Gas-Path Side of Panel) — Run Time: 4451 seconds — Start/Stop Cycles: 23*

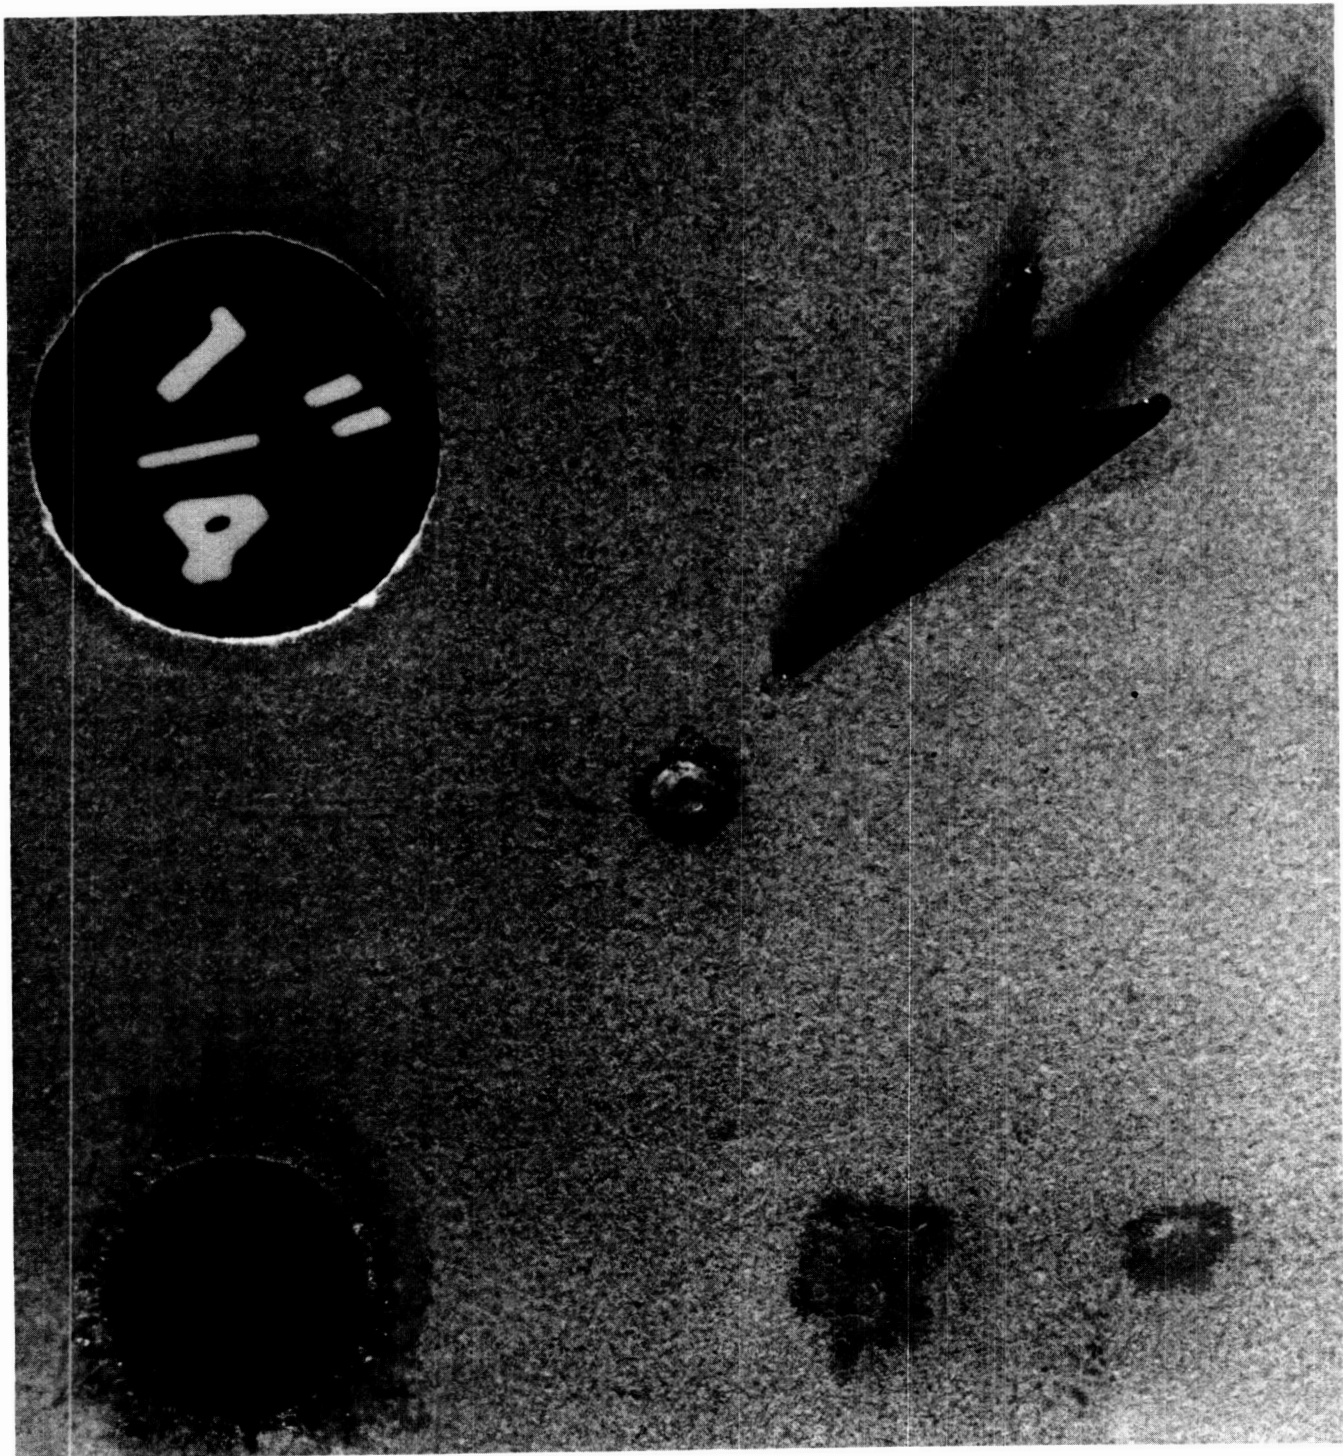
*Figure 3-15. Macro photograph of Pinhole Oxidation*

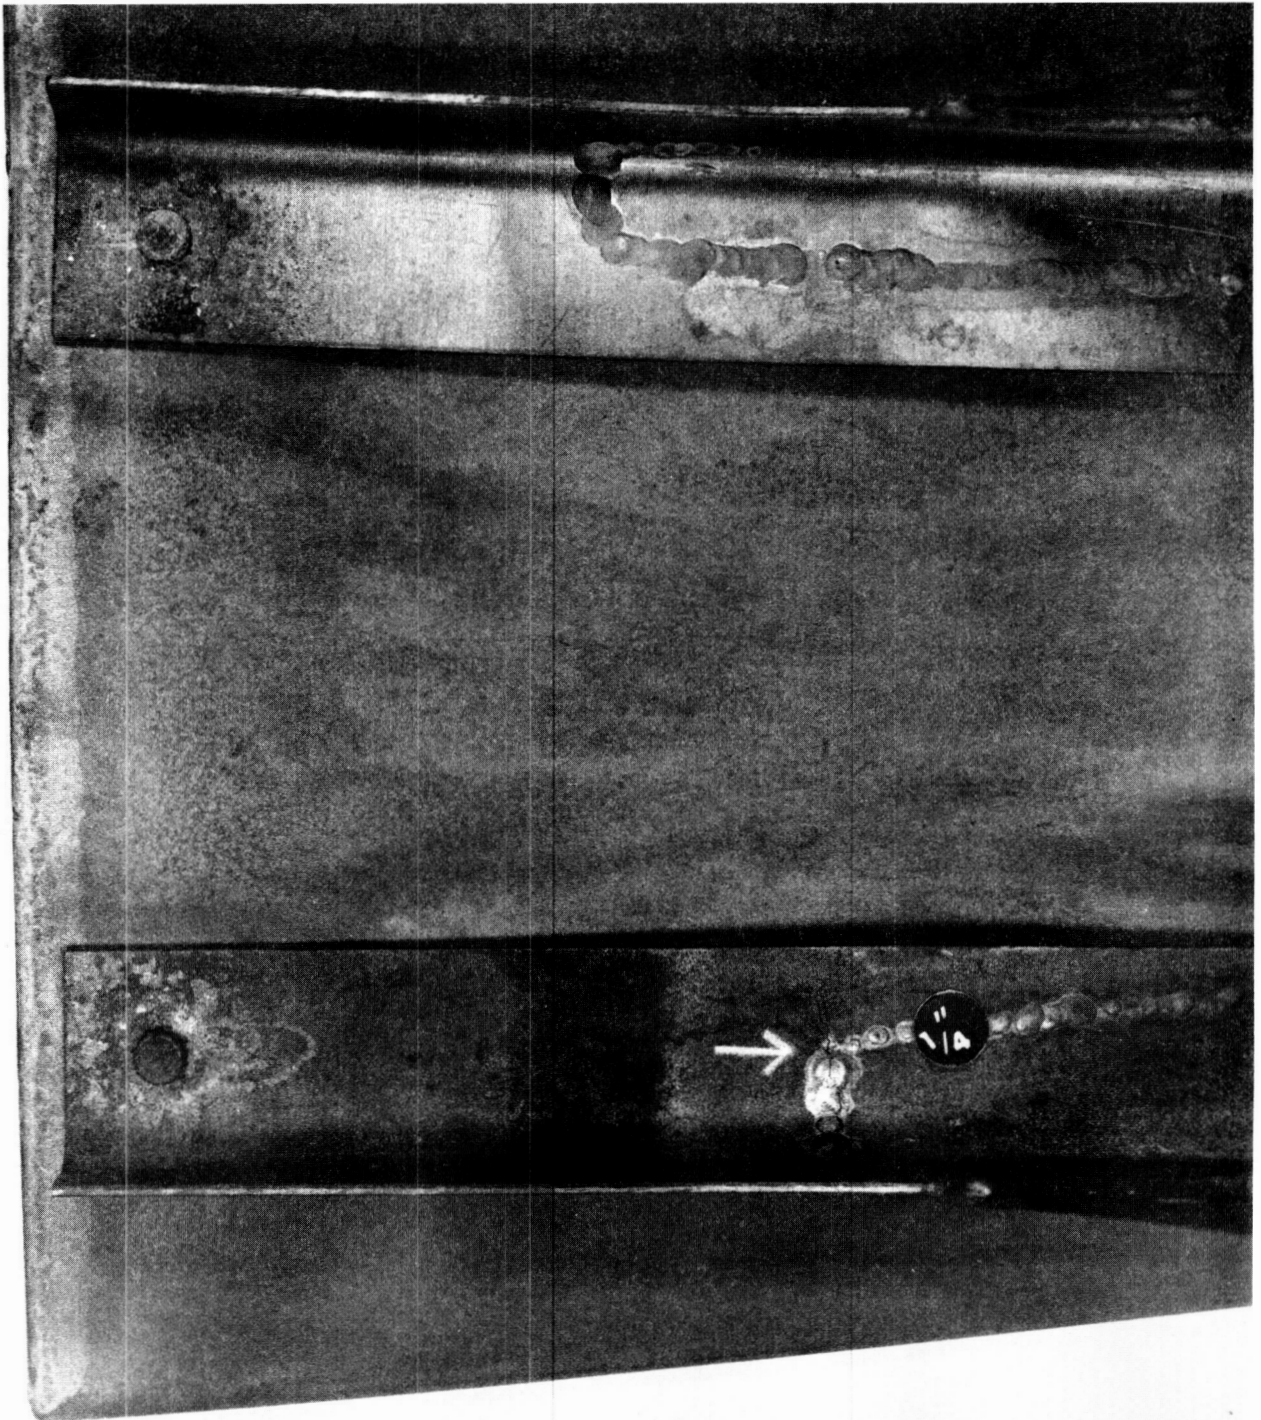
*Figure 3-28. Bracket Crack (Arrow Shows Crack in Support Bracket Which May Have Reduced Constraining Stresses, Thus Minimizing Warping)*

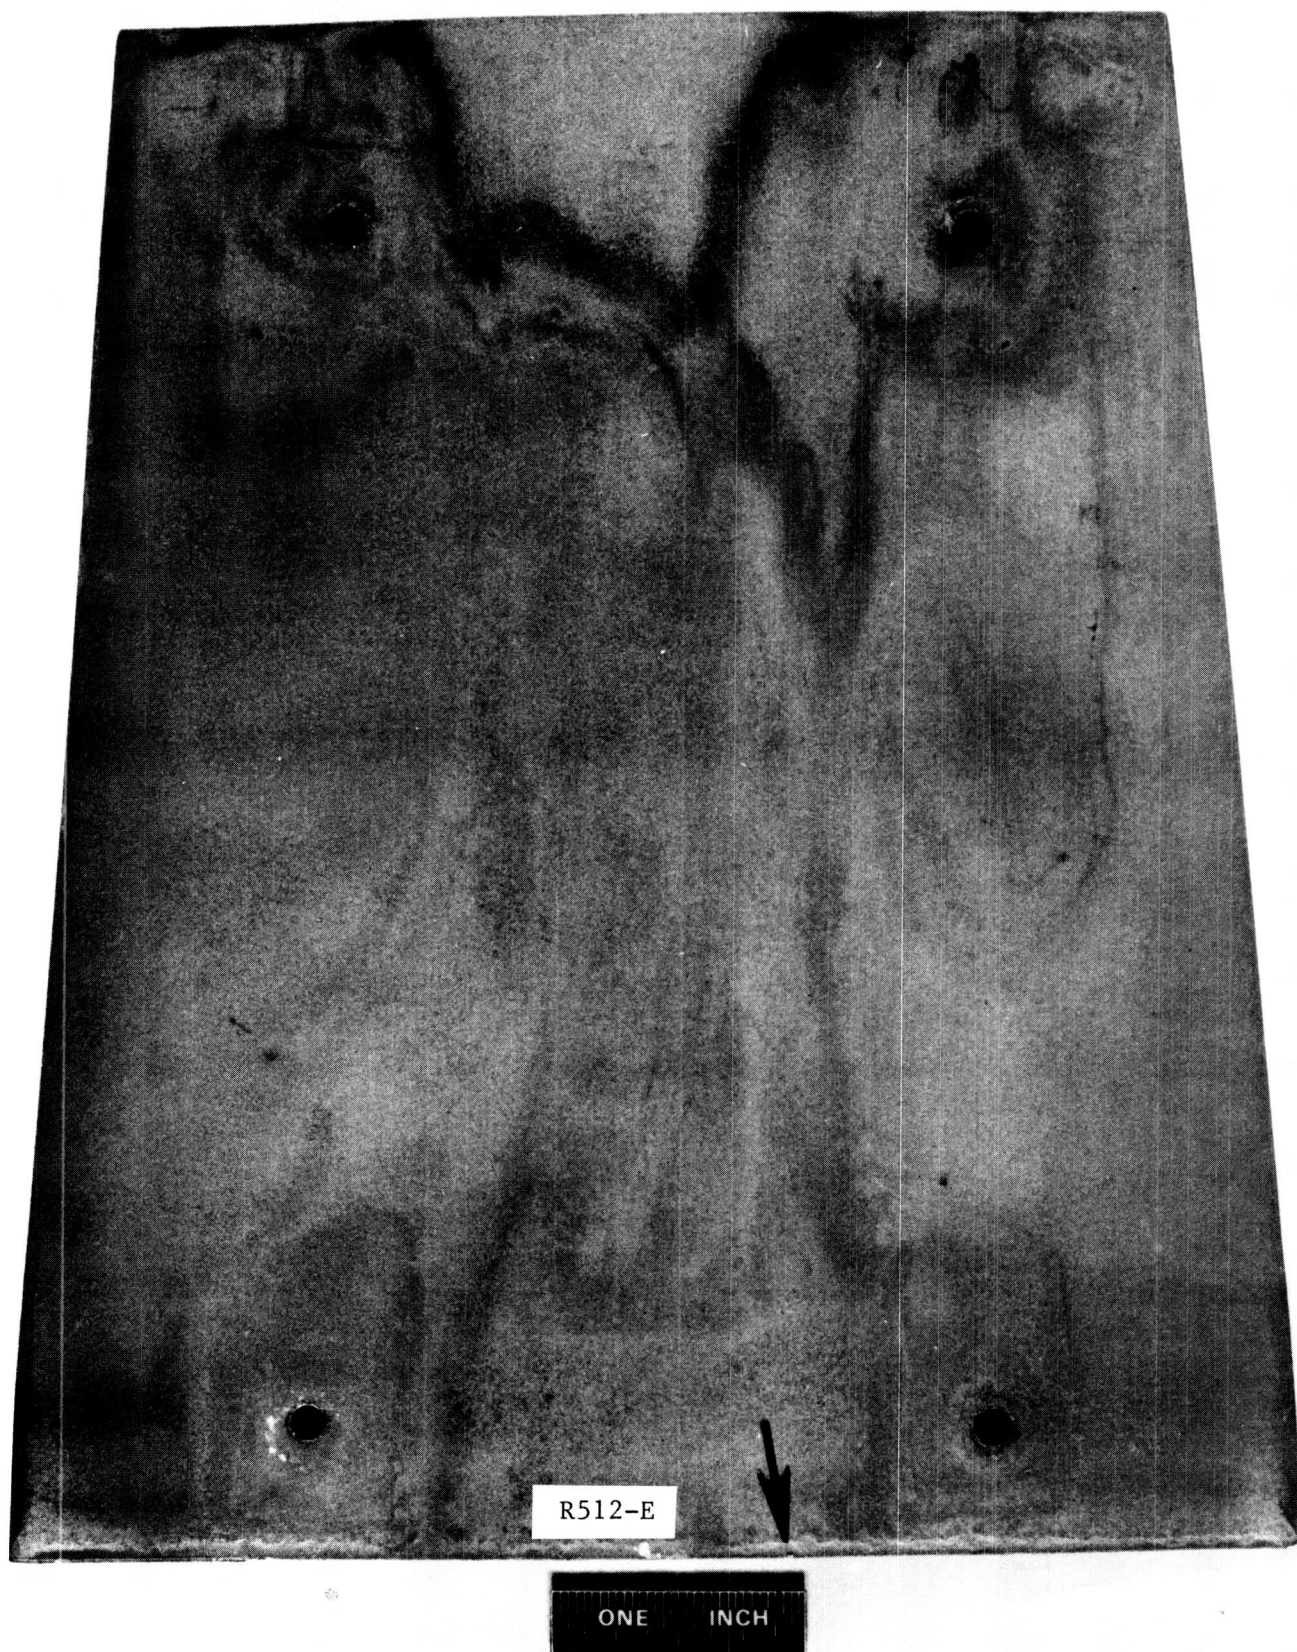
*Figure 3-29. Chamber Environment Side of R512-E Coated C-103 Test Panel (Arrow Locates a Coating Chip at Exit Plane) — Run Time: 4451 seconds — Start/Stop Cycles: 23*

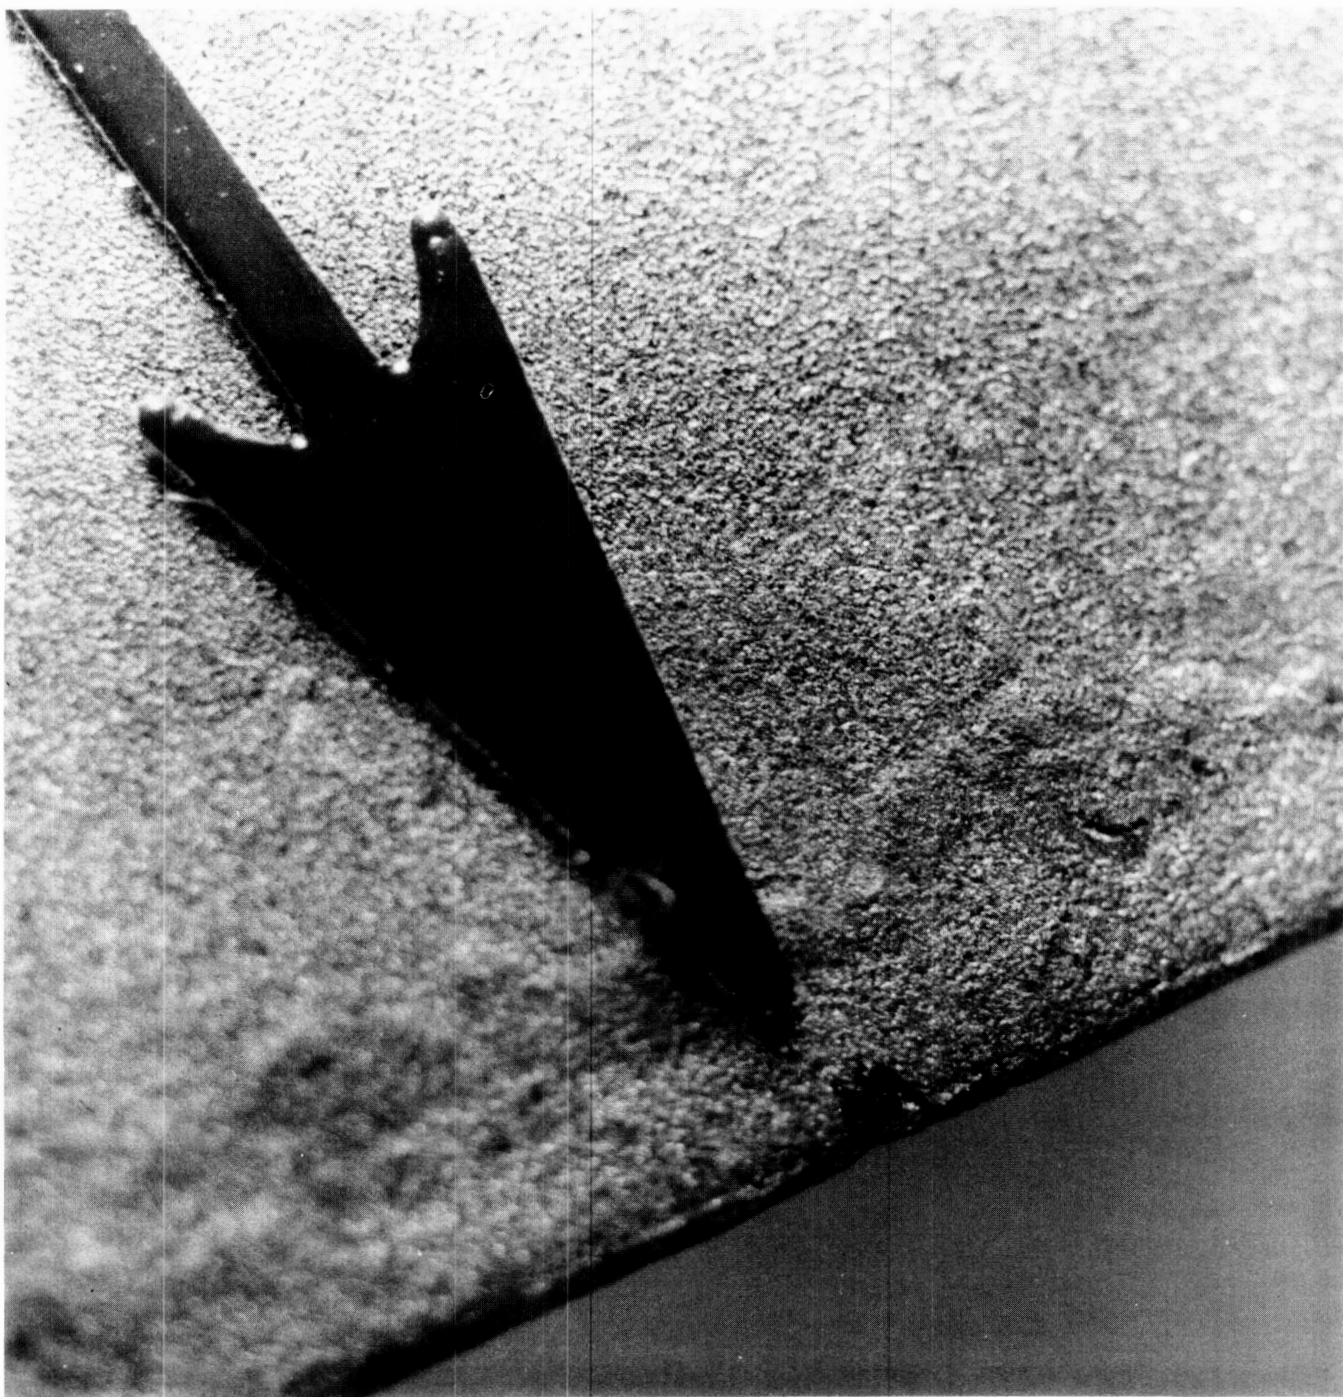
*Figure 3-30. Close-Up View of Coating Chip on Figure 3-29*
